Inspection Report
Minerals Regulatory Program
Report Date September 27, 2005

Mine Name: Wilson-Silverbell
Operator Name: Umetco Minerals

Permit number: M/037/027
Inspection Date: August 18, 2005
Time: 10:20-11:45 AM

M/037/027, Wilson/Silverbell Mine, Umetco Minerals

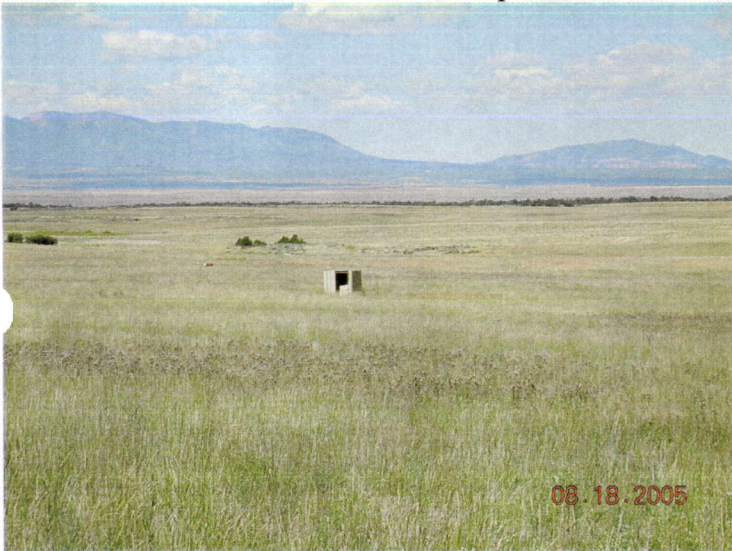
There were two structures in the field north and west of the Silverbell waste pile (Photos 1 and 2). The one shown in Photo 1 housed what appeared to be a well, but I do not know its condition. The well had a 6-inch casing, and there was a switch box with a label saying it was for the well. There was no overhead power to the well and probably no underground power. The building was wood frame with sheet metal siding. A map in the Division's file shows a well at the location I mapped.

Photo 1 The building containing the well.

I was told the compressor and well have been taken over by the land owner, but I have not been able to find anything in the files showing that the operator had approval to leave the well or the compressor and possible vent hole. These need to be reclaimed unless the operator can show that there are postmining land uses for these facilities and that the land owner desires that they remain.

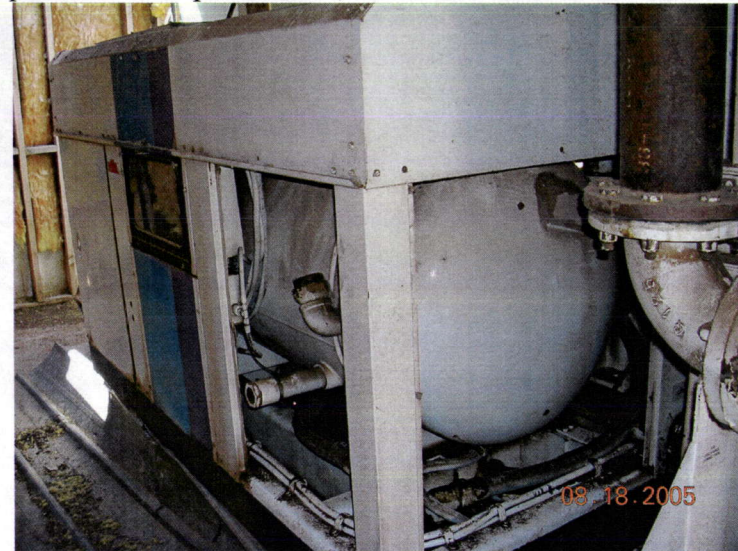
The other structure housed a compressor. The compressor had a label saying it was the property of Union Carbide Corporation which is affiliated with the operator.

The surface facilities map in the mine plan shows a vent hole and a substation at the location where the compressor is. I tried to determine whether there was a vent hole but could not clearly tell. If there is a vent hole at this location, it is covered by the pad on which the compressor rests.

Photo 3. The compressor.

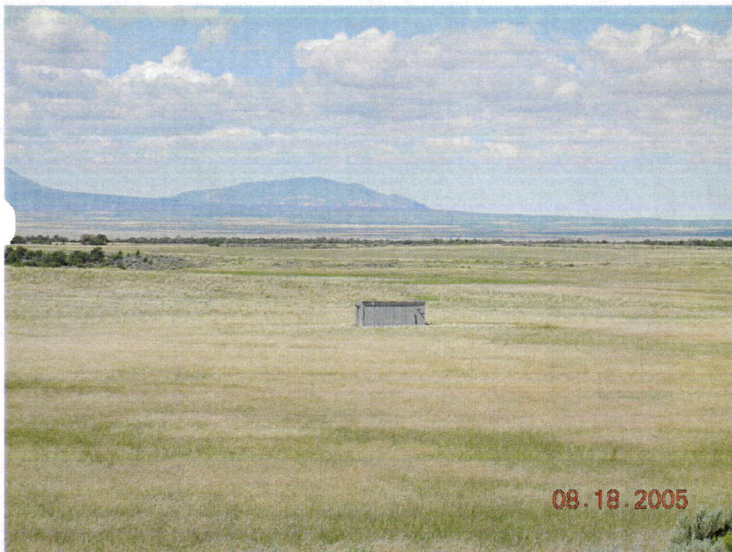
Photo 2. The building containing the compressor.

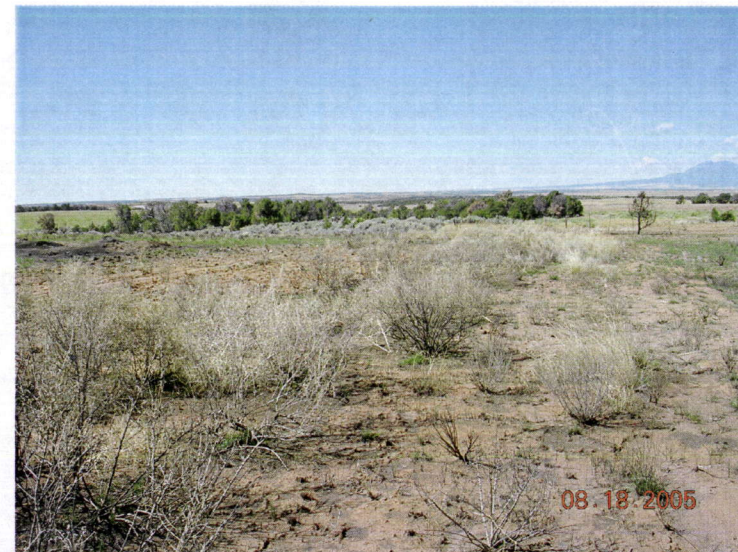
There was a recent fire in the area. Although the fire was mostly in a pinyon/juniper woodland adjacent to the mine (Photo 5), there was some damage in the reclaimed area (Photo 4). In addition,

Photo 4. A portion of the reclaimed area damaged by fire.

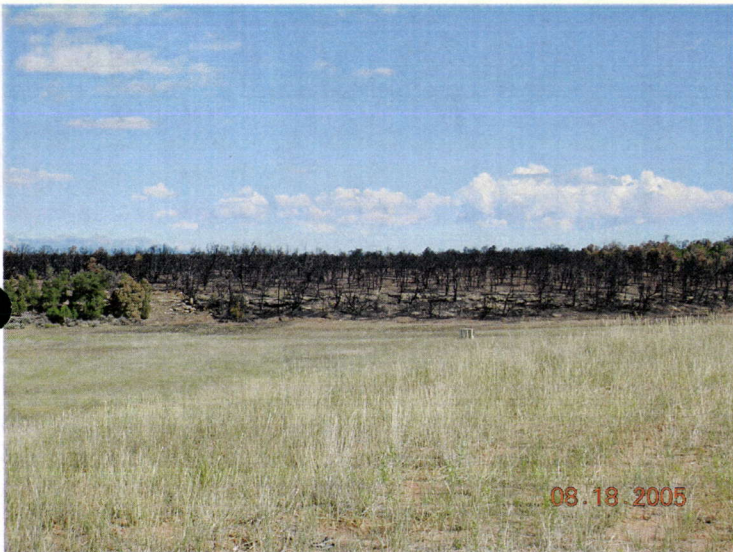
Photo 5. There was a recent fire in a pinyon/juniper woodland adjacent to the mine site.

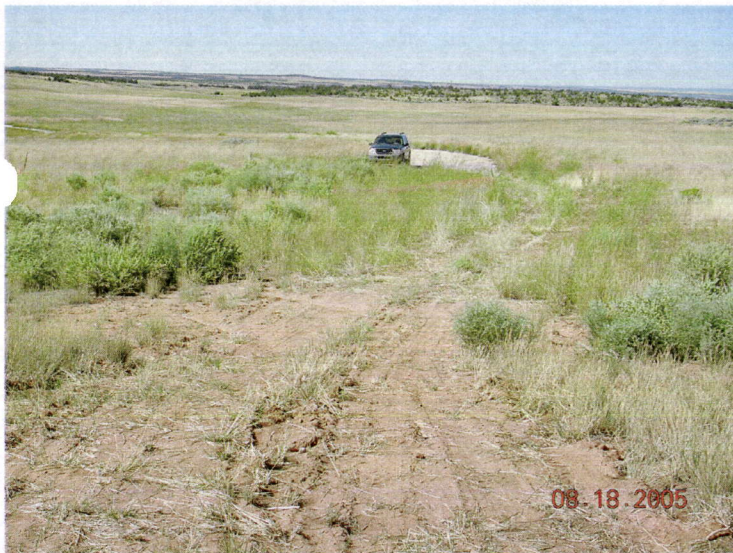
someone had been driving over the reclaimed area, apparently to get to the fire (Photo 6). The damage done by driving over the site should be temporary.

Photo 6. It appeared firefighters drove over parts of the reclaimed area to get to the fire.

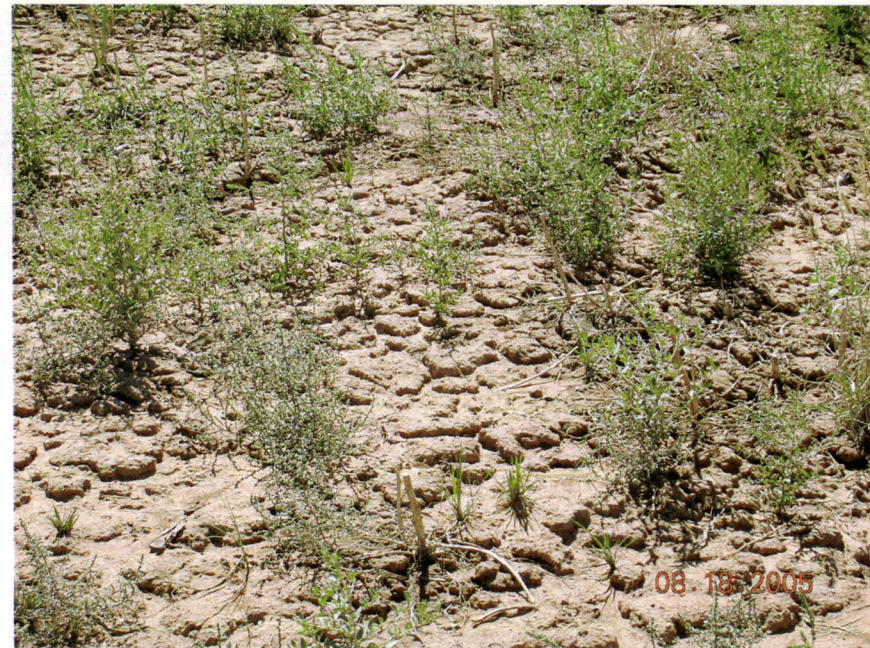
The operator reseeded the Wilson waste pile last fall, and I saw signs of increased cover from perennial species (Photo 7). There were still a lot of weeds, but there were enough perennial species that it may not be necessary to seed again to get 70 percent of the cover of adjacent areas.

Photo 7. Vegetation on the Wilson waste pile. There were quite a few weeds, but some perennial vegetation was coming in.

I expect vegetation on the Wilson waste pile to grow enough that the Division may be able to release it using normal criteria next spring. If this does not happen, the operator may want to try showing that everything practical has been done at this site and that the Division should release it on this basis.

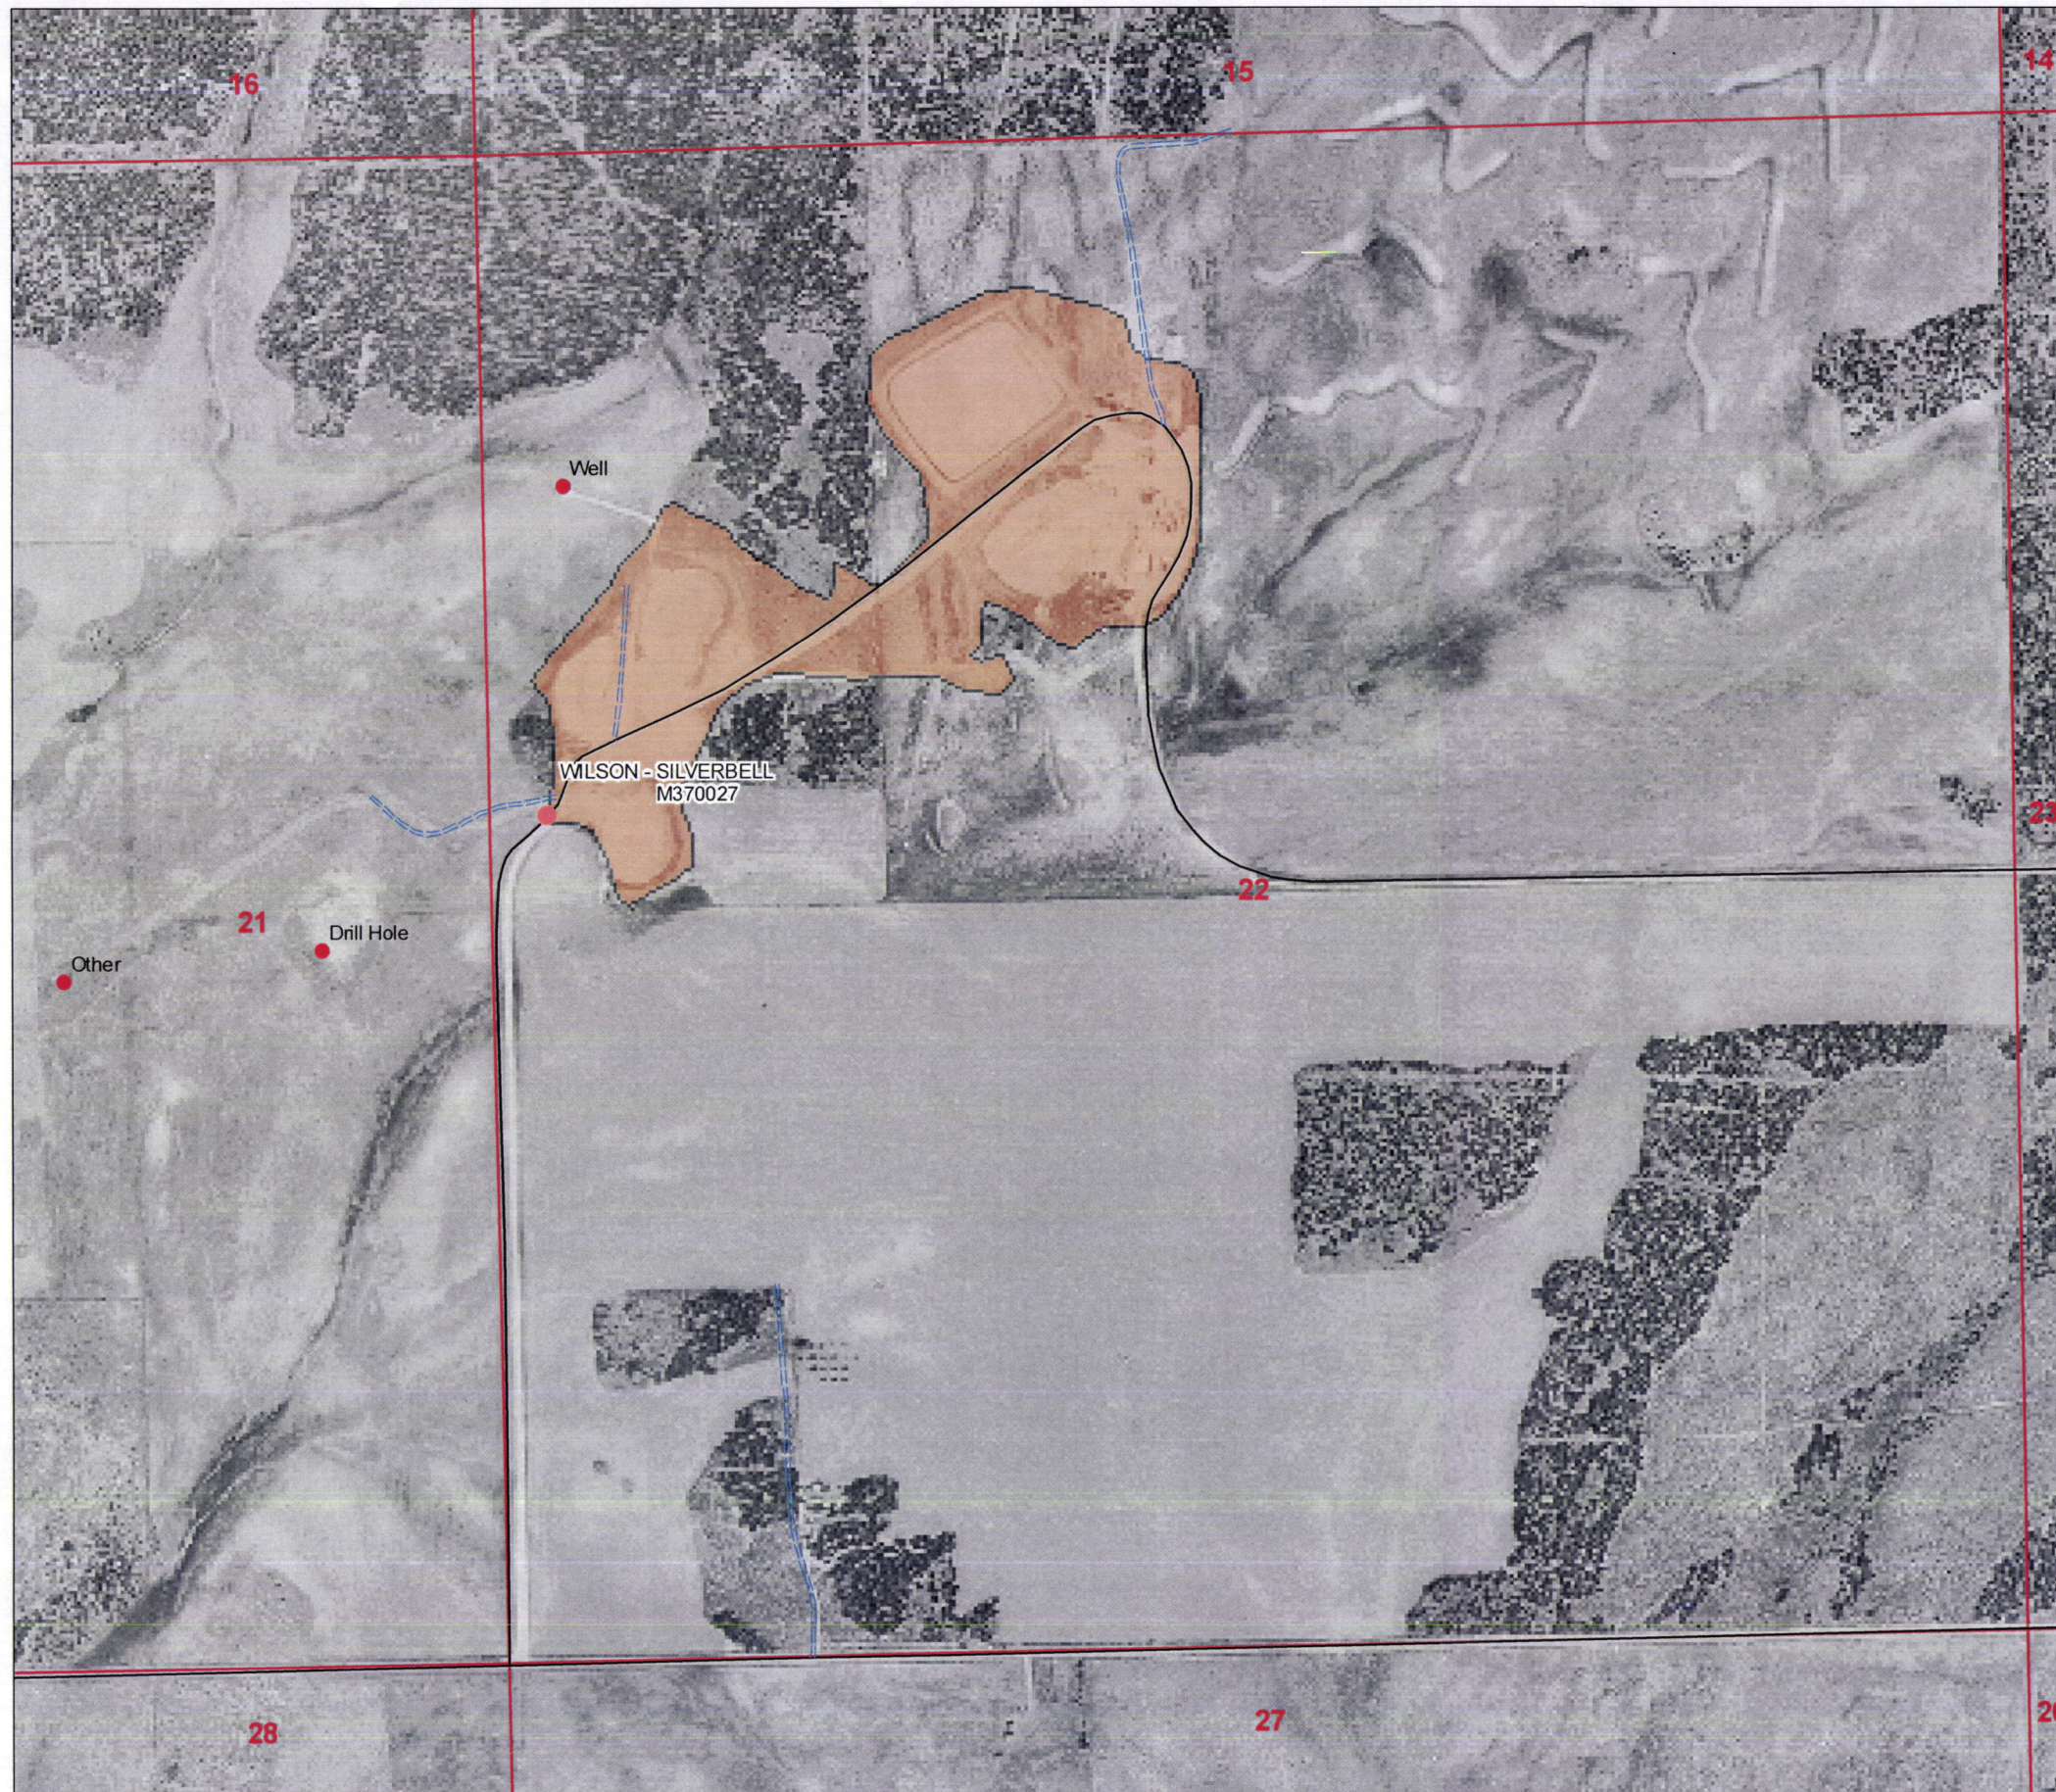
I took GPS readings at the two buildings and also at a mound that looked like it might have been a vent hole, but it appears I was mistaken. The map showing these locations is attached. On the map, the site marked "other" is the compressor, and the "drill hole" is the mound that is apparently not a drill hole.
